Detailed account of studies related groundwater in al-Khalifa

This Report aims to list the problems related to ground water in the areas of al-Khalifa and Zeinhoum; whether they were problems of water overflow (appearing in basements/ground floors/open spaces), or problems that may be causes of water overflow (networks/potholes/tanks). As well as all the studies carried out through the groundwater research project or compiled from previous projects.

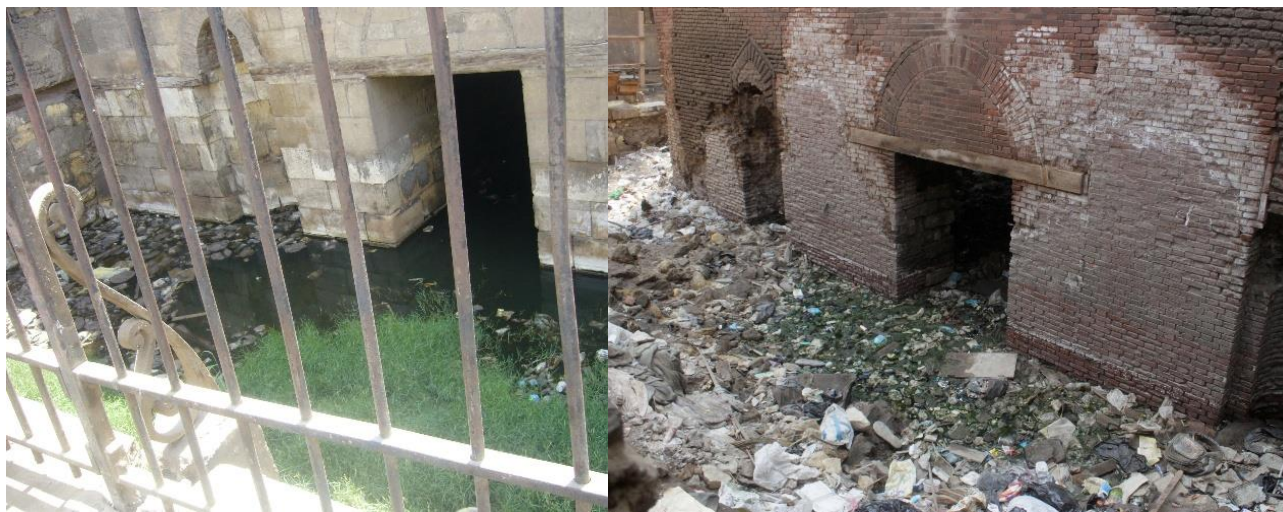
- a. Al-Ashraf Khalil and Fatima Khatun Domes
 - The two domes near al-Sayyida Nafisa square lie next to the site for Khalifa Heritage and Environment Park and suffer from rising damp, cracks as well as ground water overflow appearing in their surroundings.
 - A pisometer is installed next to Fatima Khatun Dome shows a water level beneath the ground level by 2.5 to 2.9 m. and water samples taken from it were analysed. In addition, a pisometer was installed east of Fatima Khatun pisometer in the cemetery area to compare water levels.

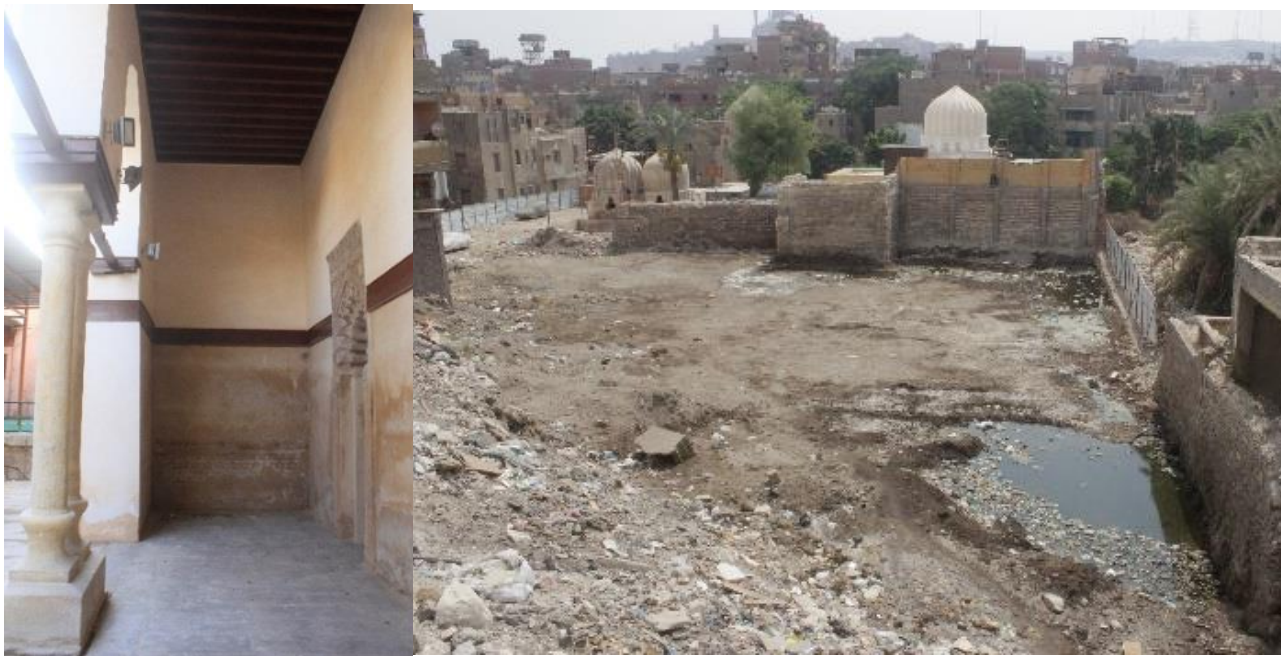
b. Al-Sayyida Ruqayya Dome:

- Street level: +516 cm (zero = al-Saliba Street).
- Monument level: +426 cm.
- Ground water level (borehole): +316.
- Ground water overflow level (neighboring empty land): +616; the water level appearing above the ground in this area, which is neighboring to the Zaynhum area, is higher than the street level.
- Effects of rising damp appear on the monument's walls up to a height of 2 meters.

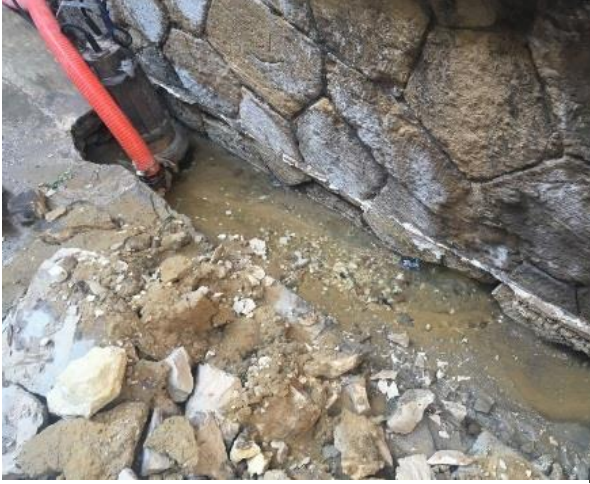
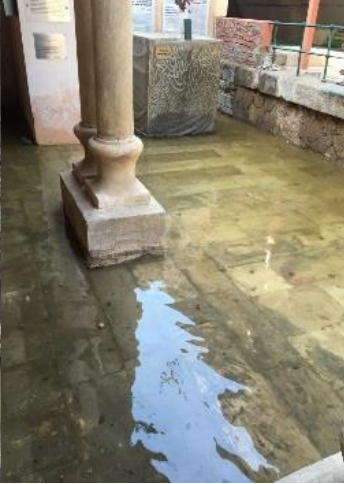
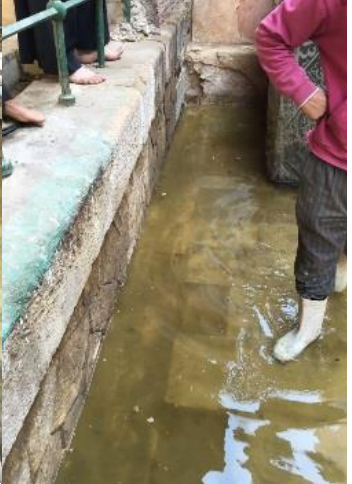
- According to local accounts, water overflows appeared several times in the S. Ruqayya Dome area, the earliest they can date is in 2012 at the time of the *mawlid* (festival), the last was in march 2017 (also the time of the *mawlid*), where the water company detected a pipe breakage and got it fixed, thereby stopping the overflow.
- Boreholes were made in this site in 2005 and 2016, and water samples from the overflowing water were analysed.

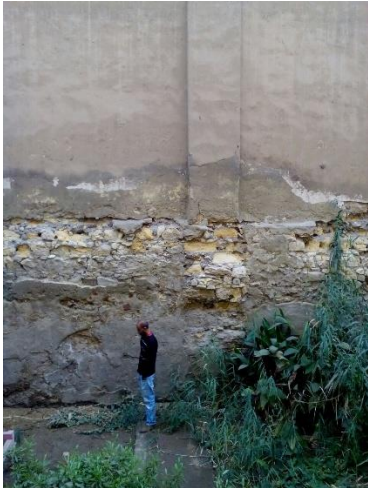
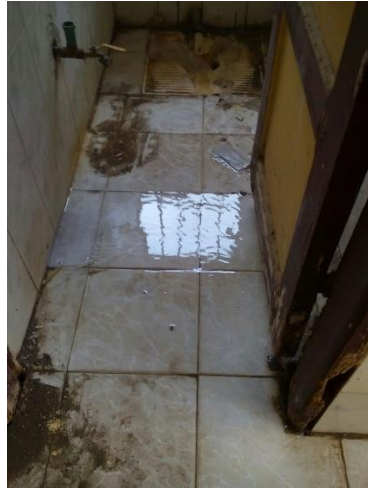
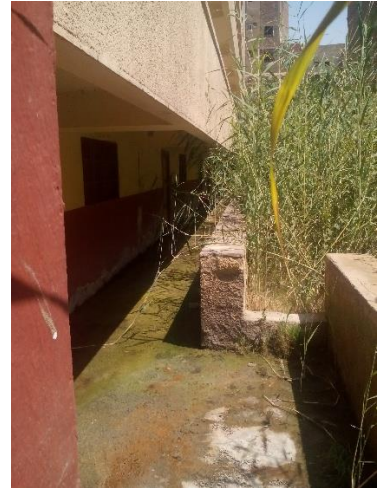
c. Shajar al-Durr school

- Water overflow appears periodically (almost yearly) in the southern and eastern sides of the school yard, and the ground floor classes.
- School sanitation is in a bad shape with water supply and sewage pipes seeping continuously
- The School is side to side to a wood factory (no. 4), whose basement is covered in water with a level higher than the water in the school by 20 cm

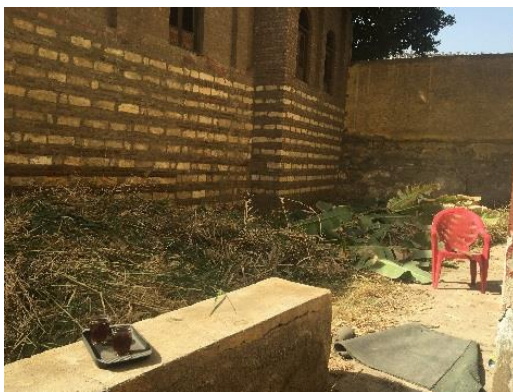
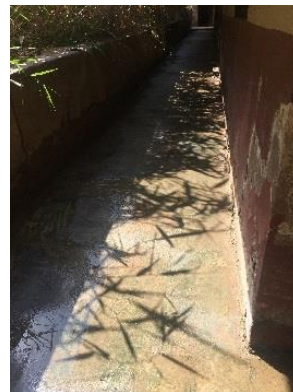
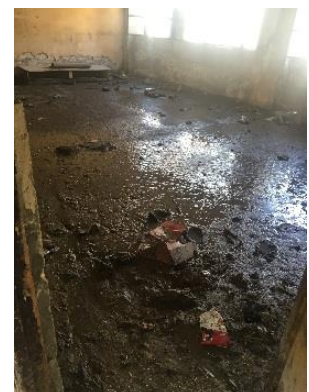
- Water levels in the school at the current moment decreased, the school is being rehabilitated for studying by cleaning the effects of water and removing undesired plants. While it is being planned to install pumps by the Cairo Governorate by the end of studying in summer to regulate the water level.

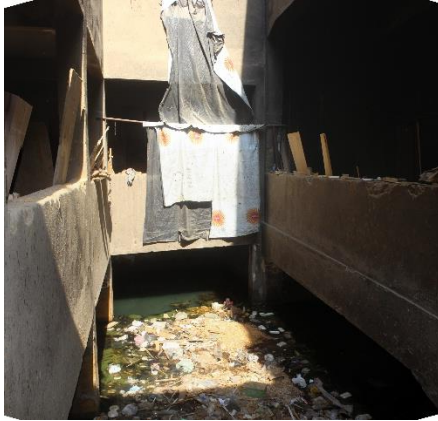
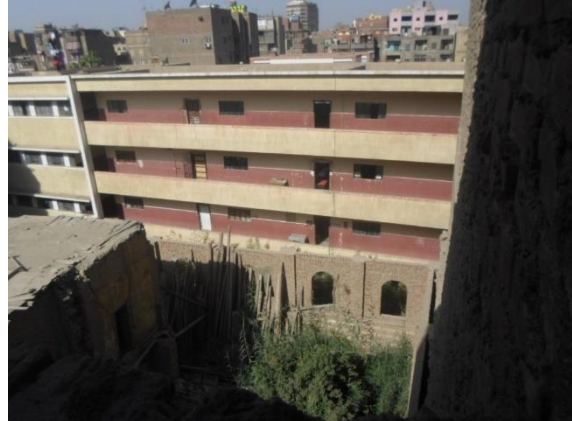
d. Wood factory (6 Darb el-Bazabiz)

- The Wood factory basement with an area of 1400 m² is covered with water with a height of 2 meters. According to local accounts, a water pipe in the street next to the factory has been

broken for years. The factory's water level is higher than that of the school by 20 cm, next to the factory is also an empty land plot where plants grow organically.

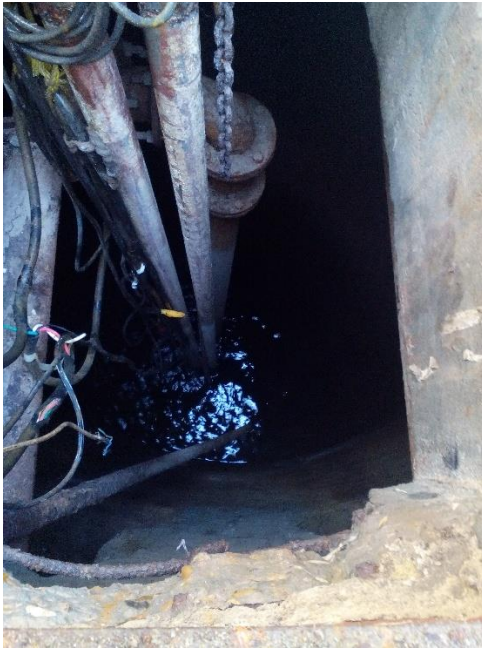
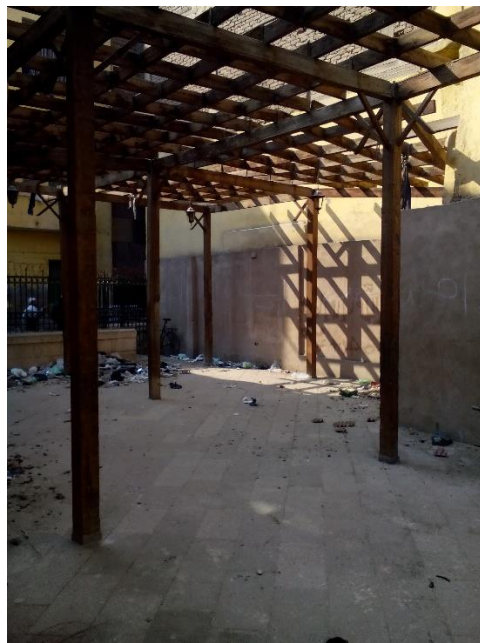
e. Ahmed Kohya mosque

- The mosque is the only structure in the area with a complete dewatering system, that decreases the water level by 3.7 meters, pumping 300 cubic meters daily

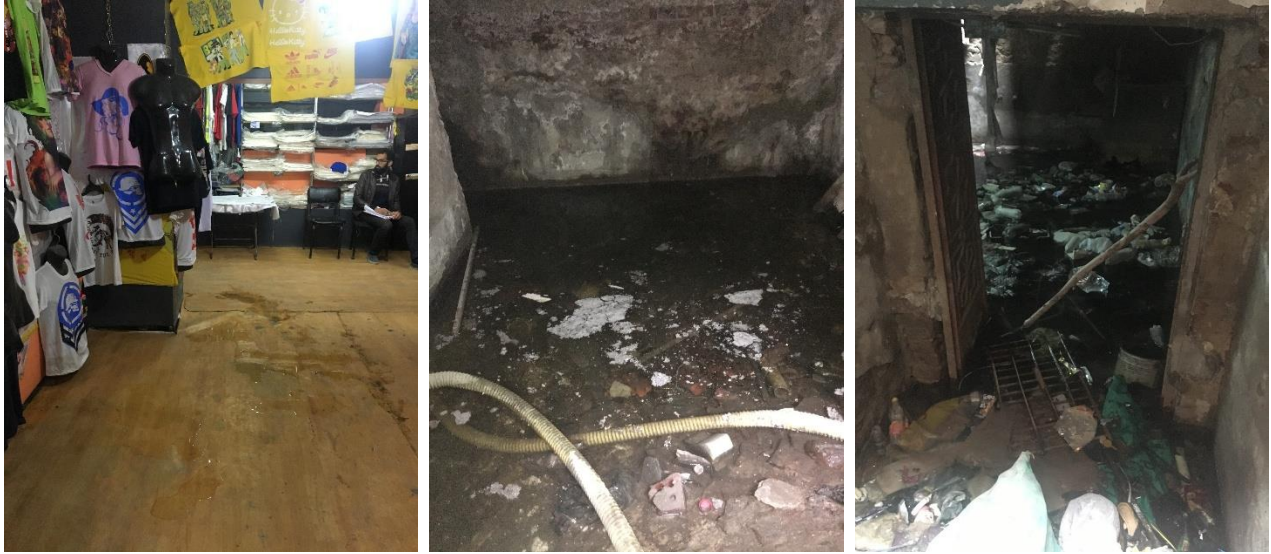
f. Residential buildings

- 23 el-Rokbeyya Street; Residents increased the 500 m² basement floor level by 1m and applied insulation, water still appears in small areas on the ground
- 37 el-Rokbeyya Street; Residents pump water out of the 173 m² basement every 4-6 weeks. The water reaches a height of about 1m and stops increasing in level.
- 20 al-Khalifa Street; basement is covered in water to a level below street level by 156 cm

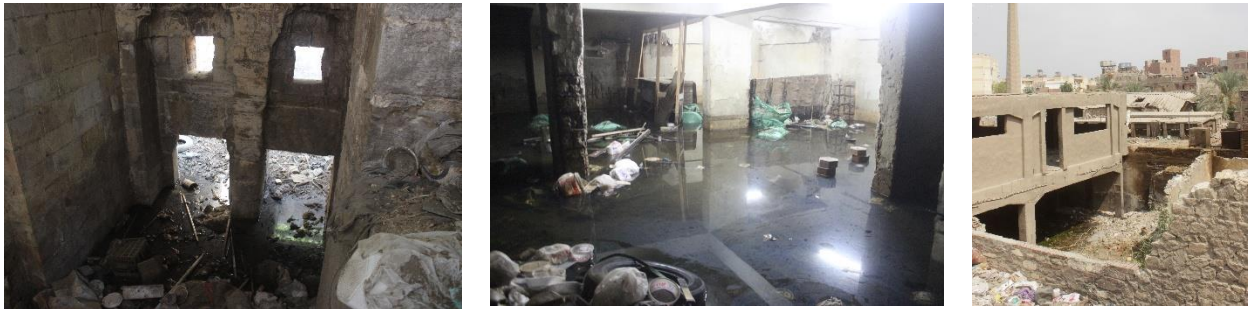
g. Other cases:

- Saffiy el din Gohar dome also suffer from overflowing water, a pisometer was installed there, and water samples from it were analyzed.
- A deserted Factory next to S. Ruqayya Dome and neighboring Zainhum has water appearing with **water level higher than street level**
- A basement in a wood workshop (69 Darb el-Masdud) next to zeinhom is covered in water
- A pisometer was installed east of Fatima Khatun pisometer in the cemetery area to compare water levels

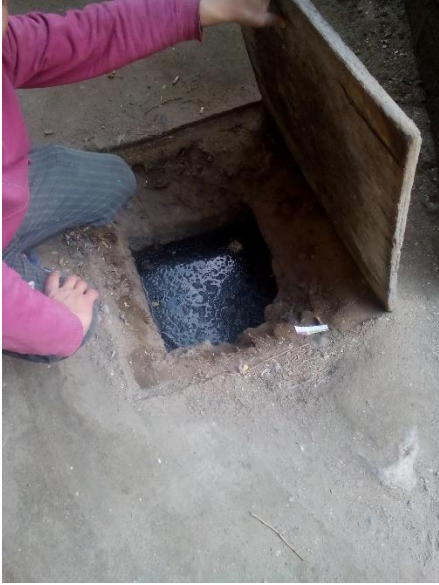
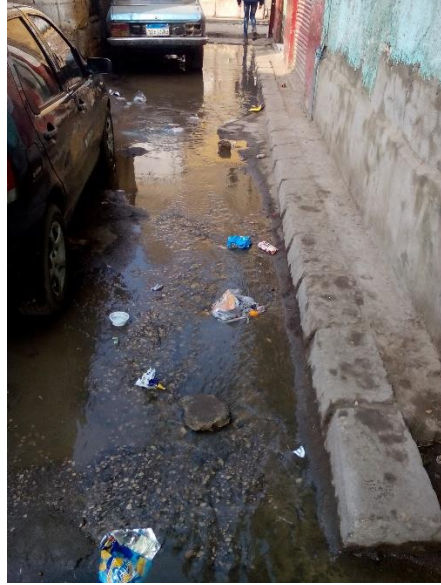
h. Inspection chambers:

- Many inspection chambers, especially in alleyways and between houses, aren't isolated or covered with a cement layer, and suffer from continuous clogging, few of those were spotted; Atfet berto bek and next to Fatima Khatun dome.
- In The area of Arba'een shrine, sewage water overflows happen every month or two

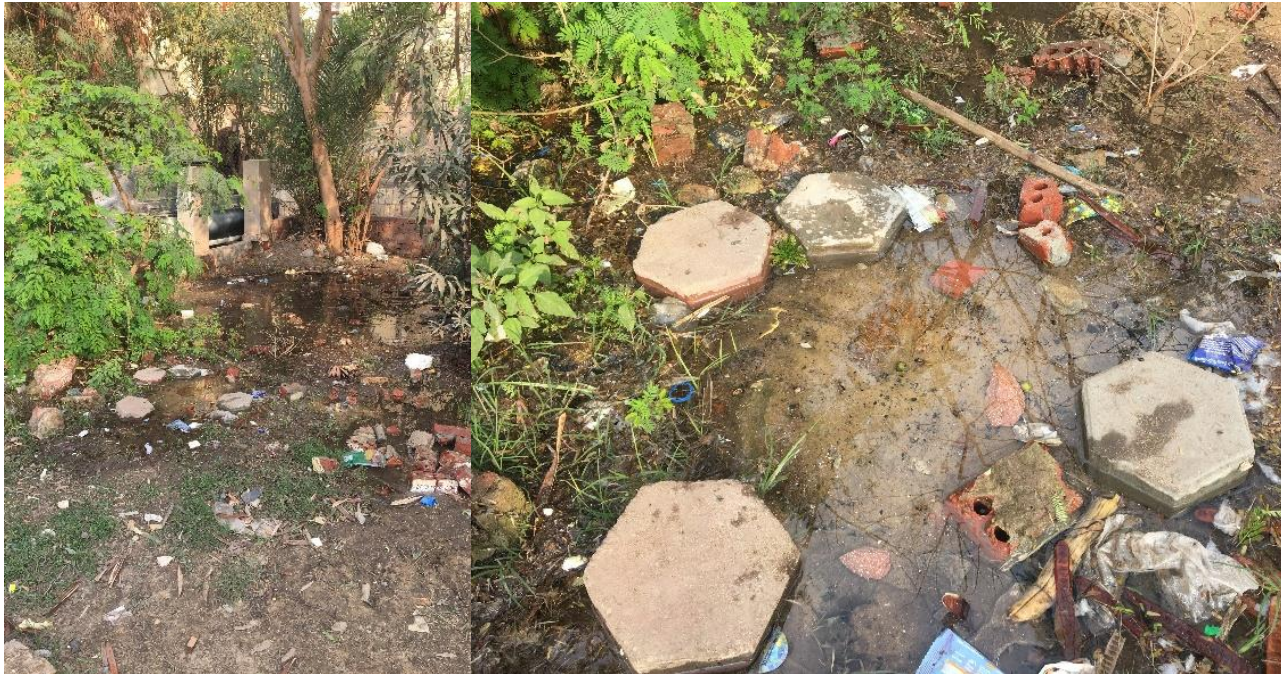
- According to local accounts the Zaynhum garden irrigation system used to work without taps. The overflow of water was suspected to cause structural problems, and the action taken by the water company was closing the openings of these irrigation pipes and burying it. Some of these pipes can now be spotted overflowing with water, while others are diverted by the residents to water their gardens.

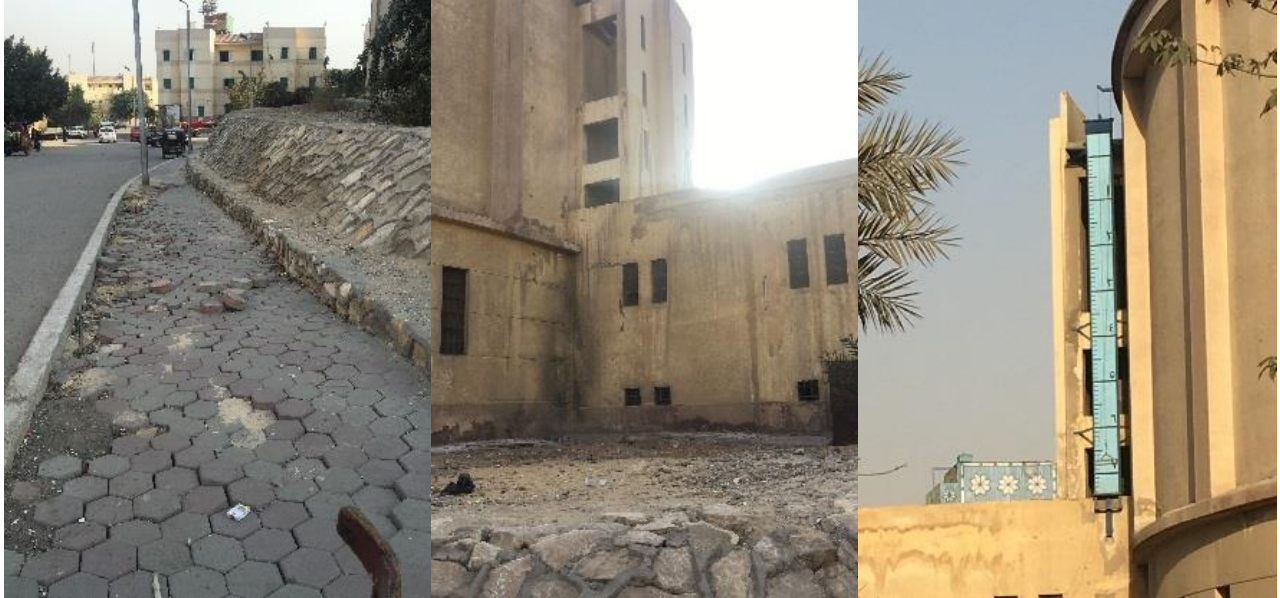
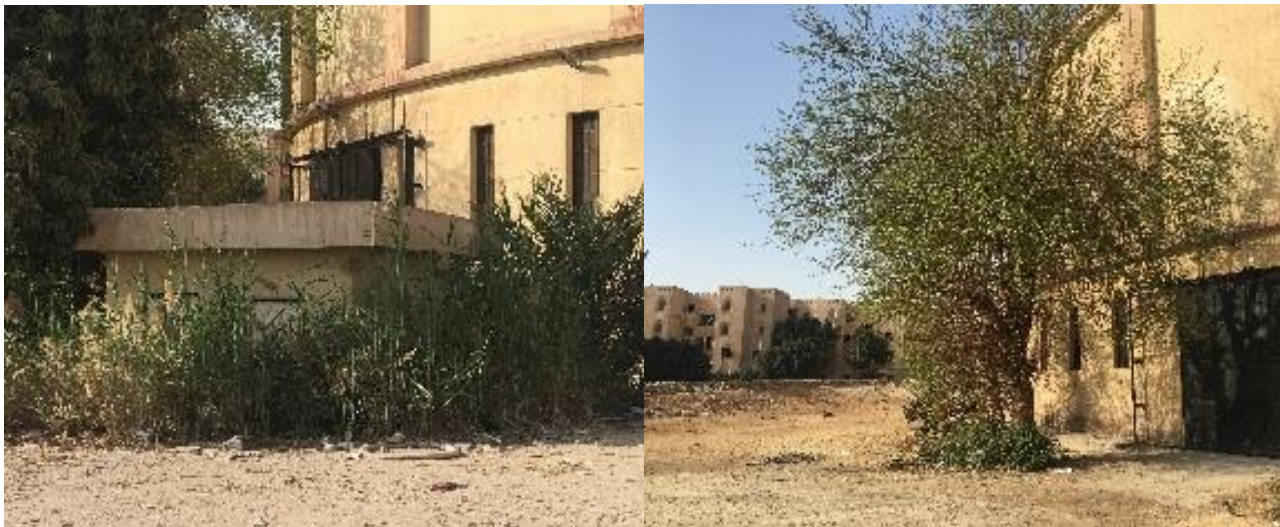
- According to local accounts, water flows out of the neighborhood water tower every few months. This is due to a problem with the water level regulator. Traces of the water appear on the building and the surrounding areas contain water ponds, soil failures and plants growing organically.
- The poor state of sanitation in the Zaynhum area appears in the damp spots on the building facades.

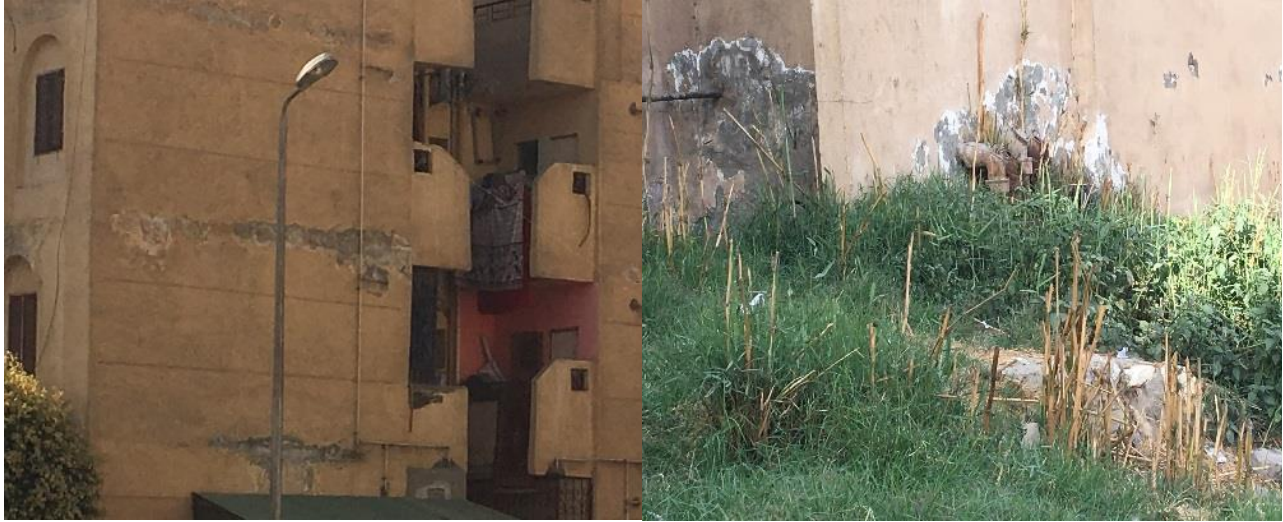
- The poor state of sanitation in the Zaynhum area appears in the damp spots on the building facades.
