Detailed account of studies related groundwater in al-Khalifa

This Report aims to list the problems related to ground water in the areas of al-Khalifa and Zeinhoum; whether they were problems of water overflow (appearing in basements/ground floors/open spaces), or problems that may be causes of water overflow (networks/potholes/tanks). As well as all the studies carried out through the groundwater research project or compiled from previous projects.

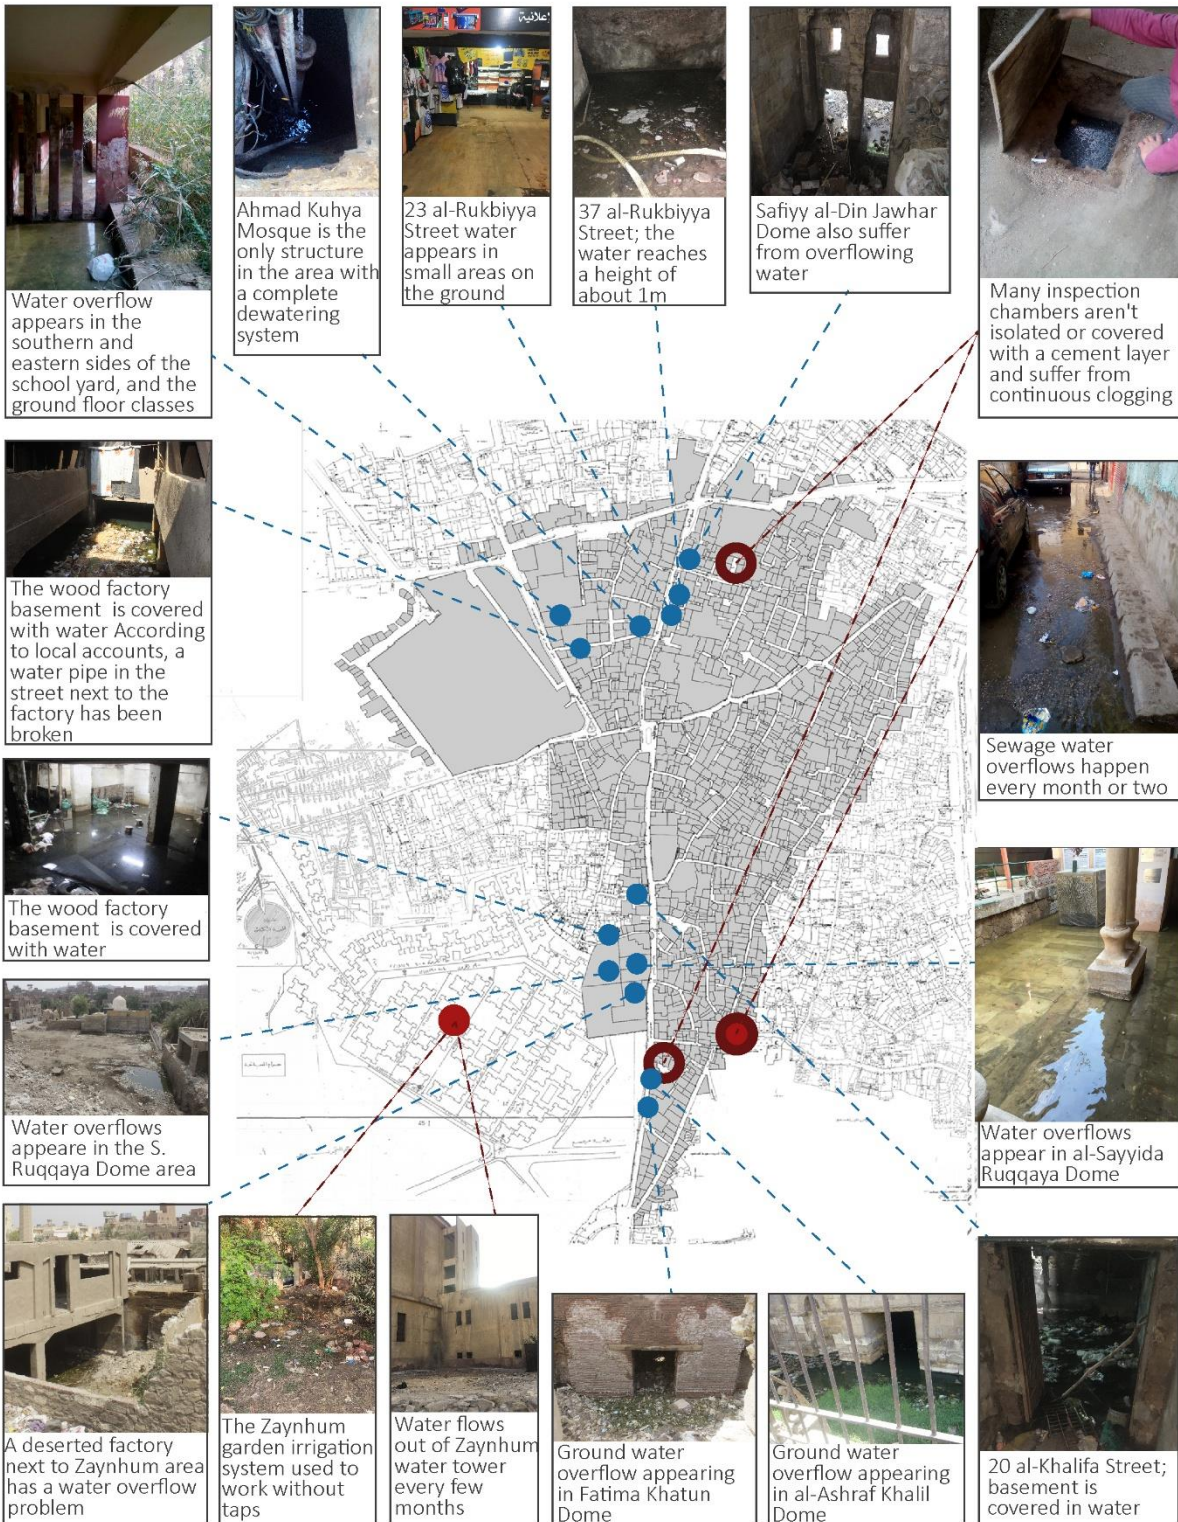
Annex 1: Map of all the places with water problems with pictures and locations

Ground Water overflows appear in several places along al-Khalifa Street (12 spotted). In addition, rising damp resulting from ground water poses a threat to a many other buildings. This is due to the streets altitude which is lower than surrounding areas. In most cases these are places lower than the street level (monuments/basements). Below are the most notable cases.

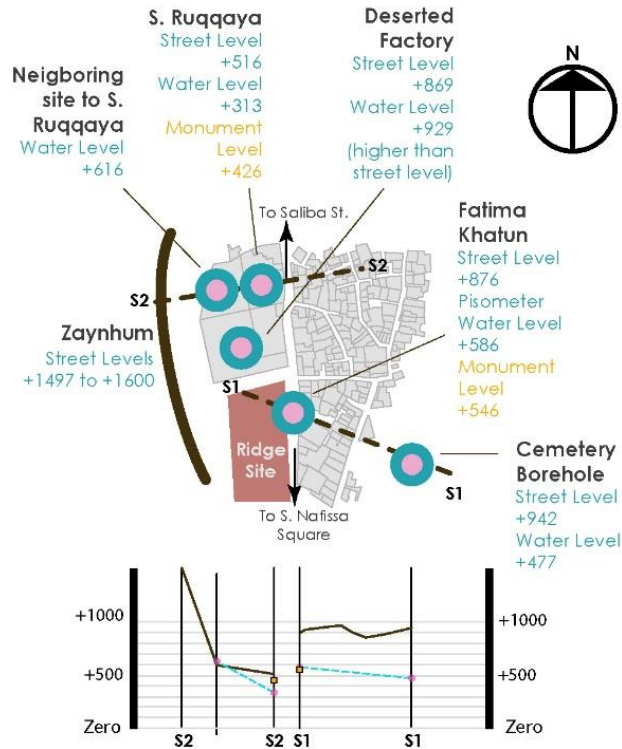
Annex 2: 3. Water levels

Water Levels in several sites next to the ridge are listed below, water levels along east-west axes appear to increase towards the west (hence Zaynhum) in a significant way.
